**DEPARTMENT OF TRANSPORTATION**

Contract #: 04-0120F4Cty: SF/Ala Rte: 80 PM: 13.2/13.9File #: 69.28**WELDING INSPECTION REPORT****Resident Engineer:**Siegenthaler, Peter**Address:** 333 Burma Road**City:** Oakland, CA 94607**Report No:** WIR-017921**Date Inspected:** 08-Nov-2010**Project Name:** SAS Superstructure**OSM Arrival Time:** 1900**Prime Contractor:** American Bridge/Fluor Enterprises, a JV**OSM Departure Time:** 700**Contractor:** Zhenhua Port Machinery Company, Ltd (ZPMC), Changxing Island **Location:** Shanghai, China**CWI Name:** See below**CWI Present:** Yes No**Inspected CWI report:** Yes No N/A**Rod Oven in Use:** Yes No N/A**Electrode to specification:** Yes No N/A**Weld Procedures Followed:** Yes No N/A**Qualified Welders:** Yes No N/A**Verified Joint Fit-up:** Yes No N/A**Approved Drawings:** Yes No N/A**Approved WPS:** Yes No N/A**Delayed / Cancelled:** Yes No N/A**Bridge No:** 34-0006**Component:** Tower and OBG Components**Summary of Items Observed:**

## WELDING INSPECTION REPORT

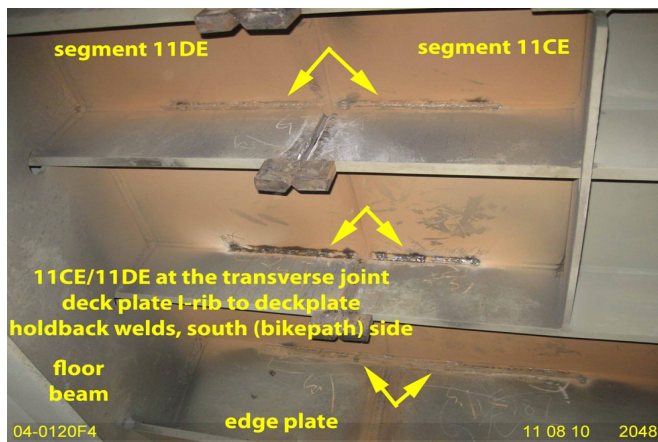
SMAW welding of weld joints DP719-001-013~018 and DP720-001-007~012 located inside PCMK OBG 11CE/11DE at the transverse joint, deck plate I-rib to deckplate, holdback welds, south (bikepath) side. See photo below. Welder was identified as 050289. QC was identified as QC1. Welding variables recorded by QC1 appeared to comply with WPS-B-T-4114-1 as verbally identified by QC1.
